# Test Report

**Report No.: TS20174050**

<b>Applicant</b>	Bagco Asia Ltd
<b>Address</b>	Suite 1902,Tamson Plaza, 161 Wai Yip Street, Kwun Tong, Kowloon
<b>Sample Name</b>	Kemsing PVC
<b>Type/ Model</b>	/
<b>Color</b>	Black
<b>Sample Received Date</b>	2017-07-25
<b>Test Period</b>	2017-07-25~ 2017-07-28
<b>Test Requirement</b>	To determine the following items in the submitted sample(s) according to the client's requirement.

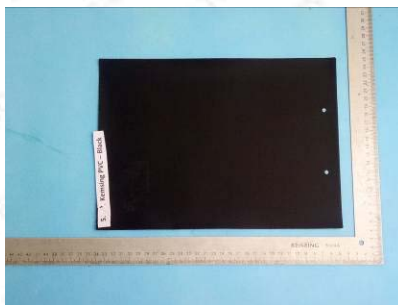
No.	Sample Serial No.	Test Component(s)
001	TS20174050001	Kemsing PVC
